# Manhole Inspection Summary

Manhole # S49K\_\_033MH

Insp Date: **3/28/08 9:17 AM**

**Location** Address: **2542 S Luzerne Av**

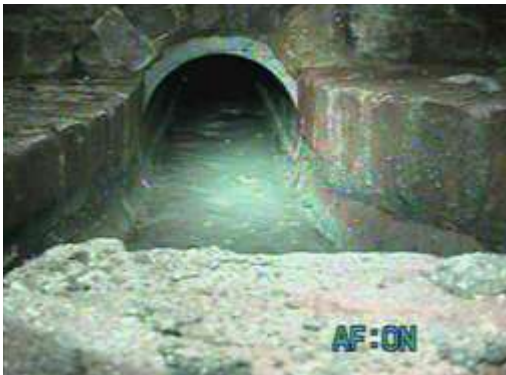
Defect 3

Condition: ☐ Sound ☐ Cracked ☐ Root Intrusion ☐ Deteriorated ☐ Leaks ☒ **Debris**

channel cond debris

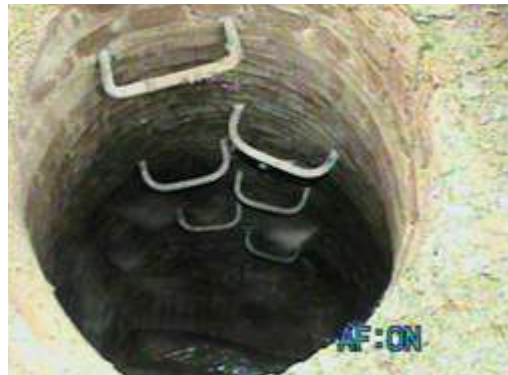
Defect 2

Count: **6** Missing: **0** ☒ **Corroded**

corroded stairs

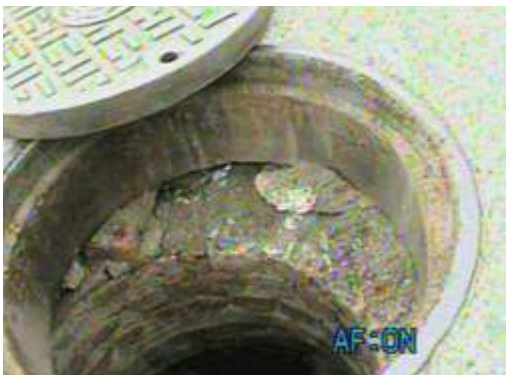
Defect 1

Offset: **6** (in.)

Condition: ☐ Sound ☐ Cracked ☐ Root Intrusion ☒ **Loose Brick** ☐ Deteriorated

loose bricks, off set frame

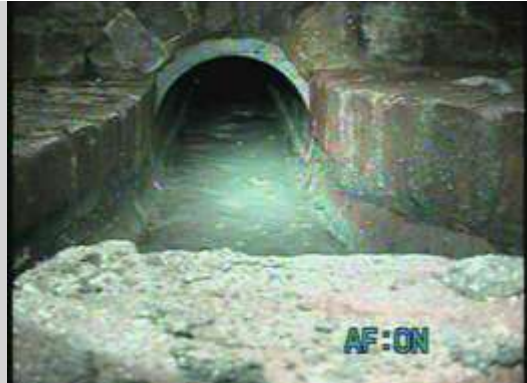
12 O'Clock Outflow

10 in. Circular Gravity Sewer  
Pipe Out @ 12 O'Clock

Invert Depth: 11.24 (ft.) Flow Characteristics: **Fast**

Deposits: ☒ None ☐ Mud ☐ Sludge ☐ Debris ☐ Grease

Infiltration: **None** Pipe Seal Cond: **Unknown**

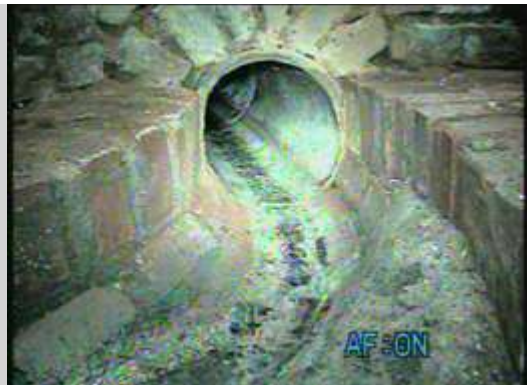
3 O'Clock Inflow

8 in. Circular Gravity Sewer  
Pipe In @ 3 O'Clock

Invert Depth: 10.03 (ft.) Flow Characteristics: **Fast**

Deposits: ☒ None ☐ Mud ☐ Sludge ☐ Debris ☐ Grease

Infiltration: **None** Pipe Seal Cond: **Unknown**

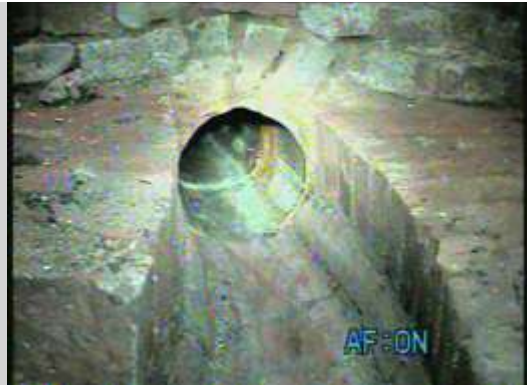
6 O'Clock Inflow

8 in. Circular Gravity Sewer

Pipe In @ 6 O'Clock

Invert Depth: **10.05** (ft.) Flow Characteristics: **Fast**

Deposits: ☒ None ☐ Mud ☐ Sludge ☐ Debris ☐ Grease

Infiltration: **None** Pipe Seal Cond: **Unknown**
